Recovery of Copake Lake's Water Quality and Control of Nuisance Aquatic Vegetation

Alejandro Reyes, CLM

Dr. George Knoecklein, CLM

Northeast Aquatic Research

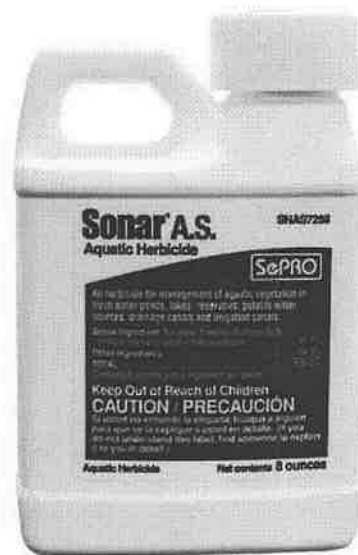
- Whole lake fluridone treatment in 2002
- 30% of entire surface area was covered with Eurasian Watermilfoil.

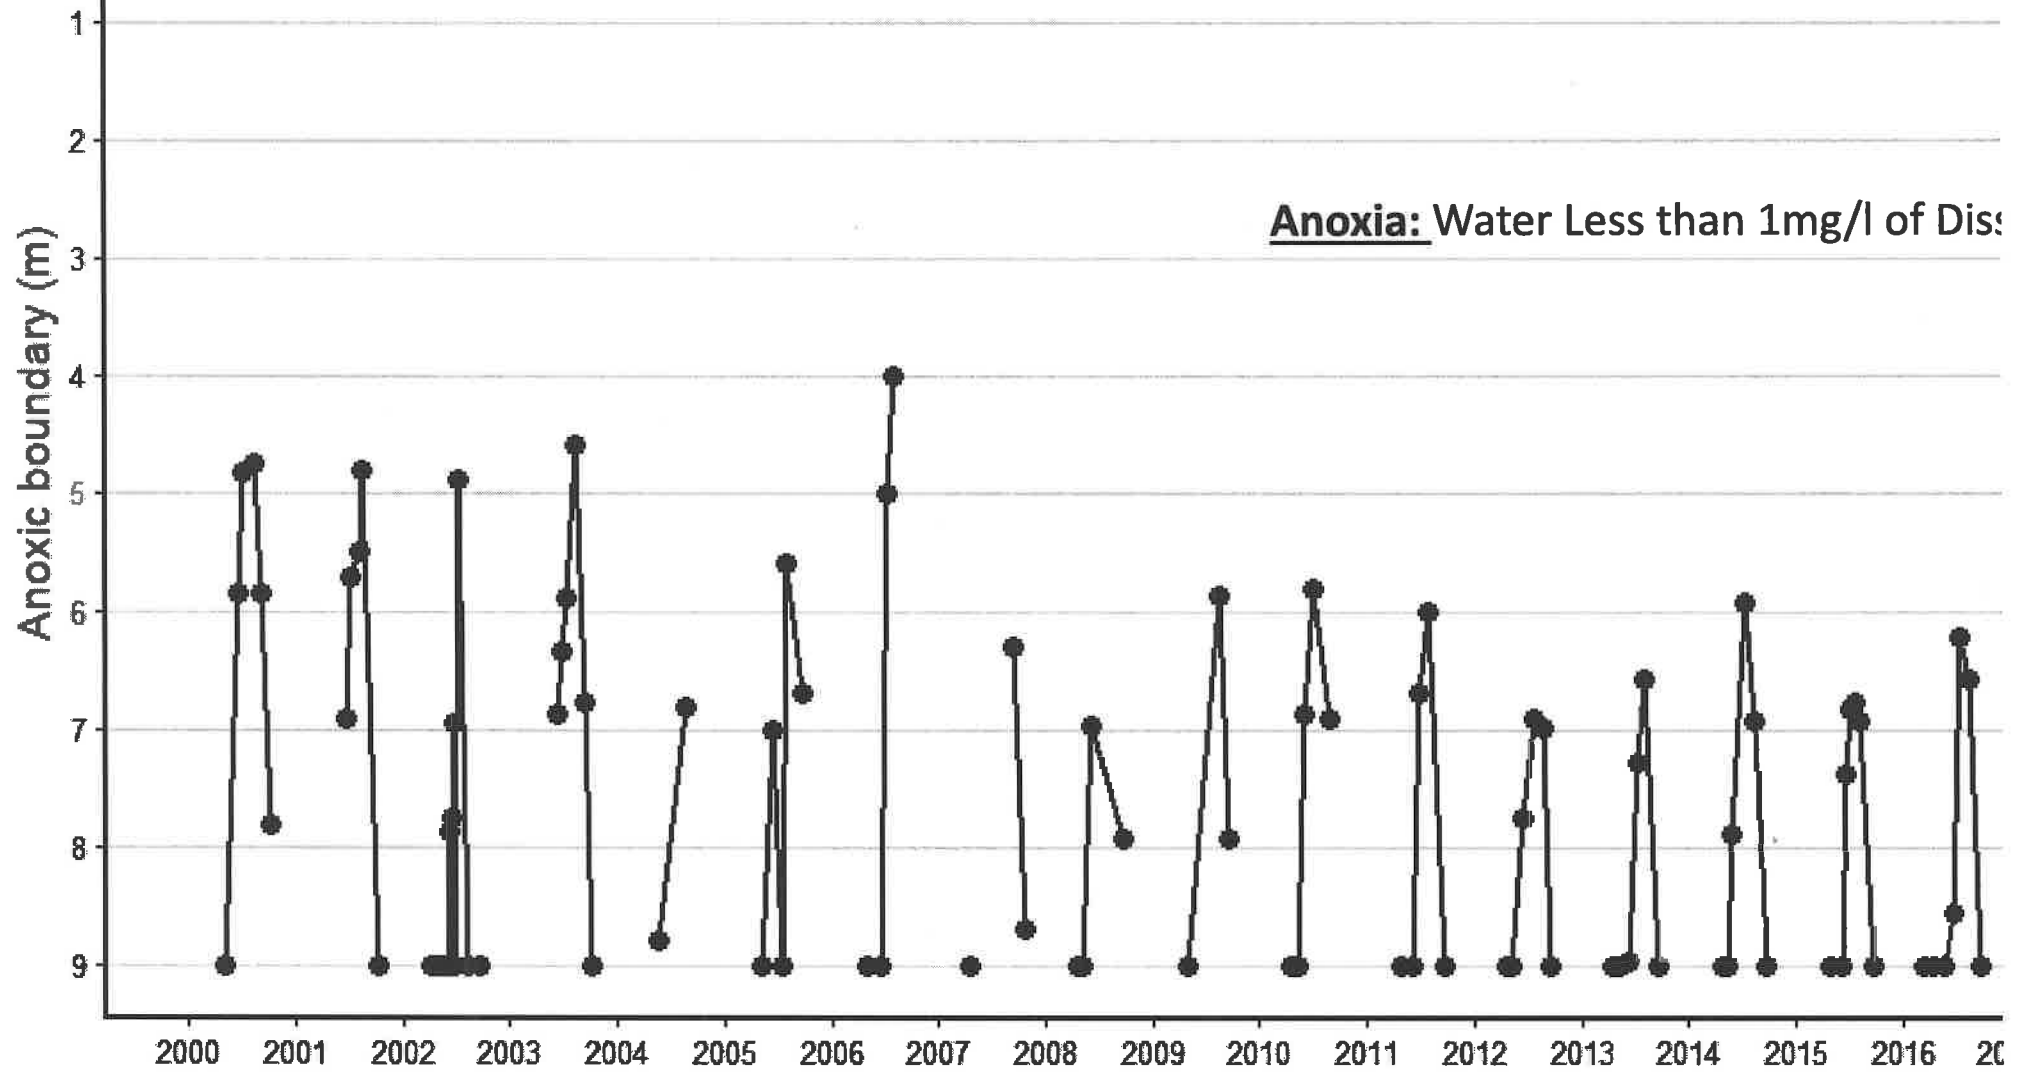
Anoxic Boundary

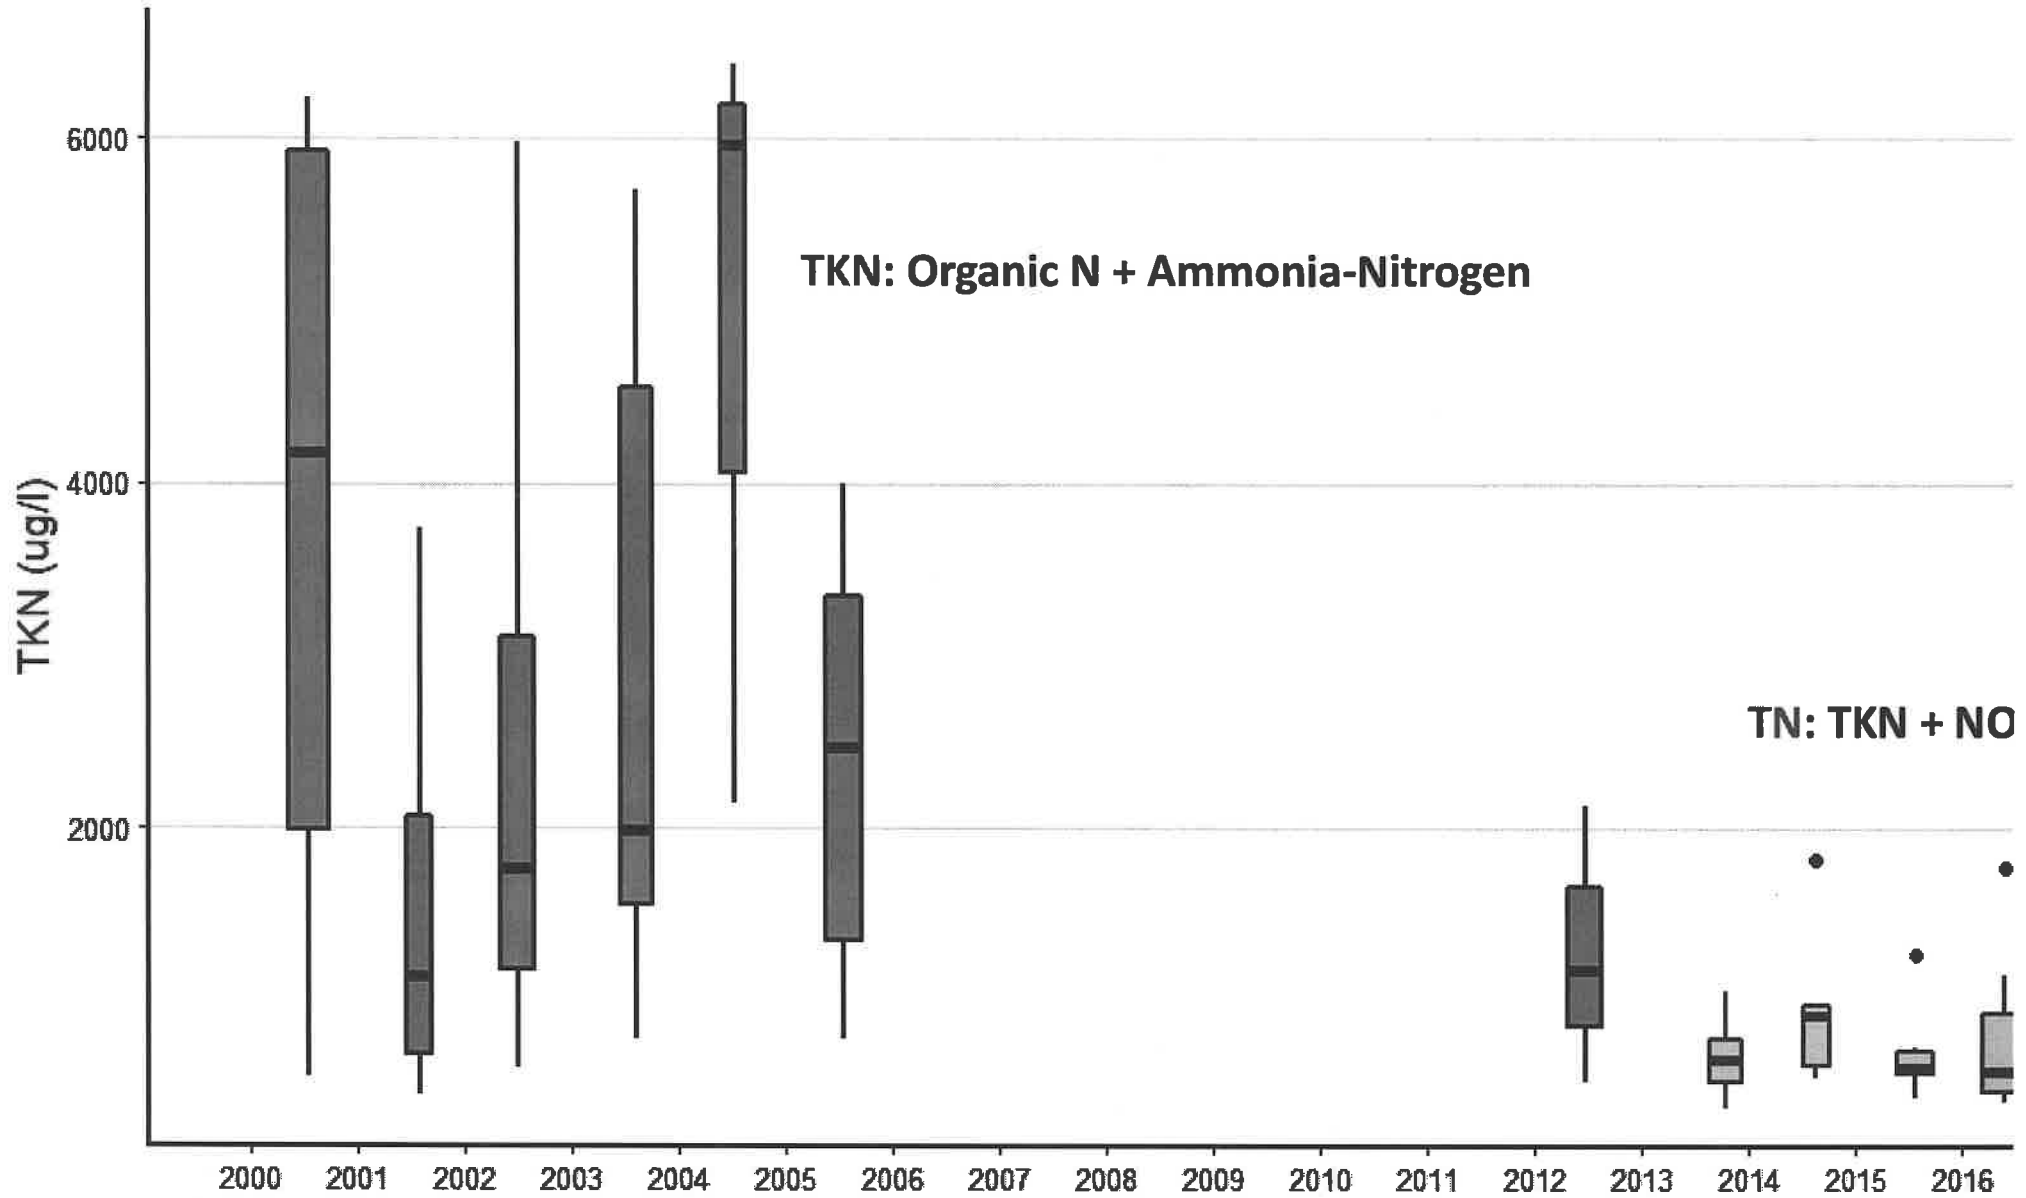
Bottom Total Kjeldahl Nitrogen and Total N
